**Mainline 6B 2012 Maintenance and Rehabilitation & Line 6B Replacement Projects**  
**IDEM Water Quality Certification Independent Environmental Monitor Weekly Observation Report**

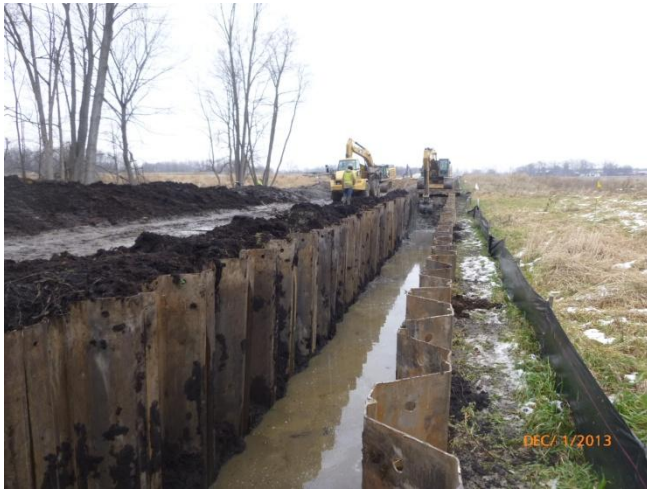
w-516-a trenching began in compliance, Sta.#2705+52.

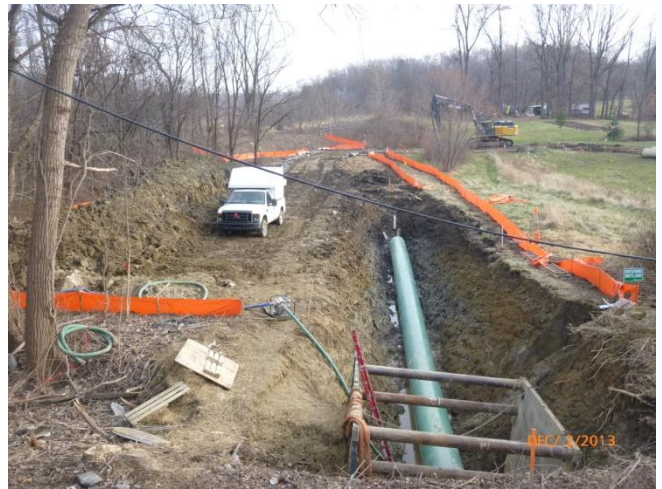
W-488-y adjacent to Calumet Ave. bore, Sta#.1225+25.

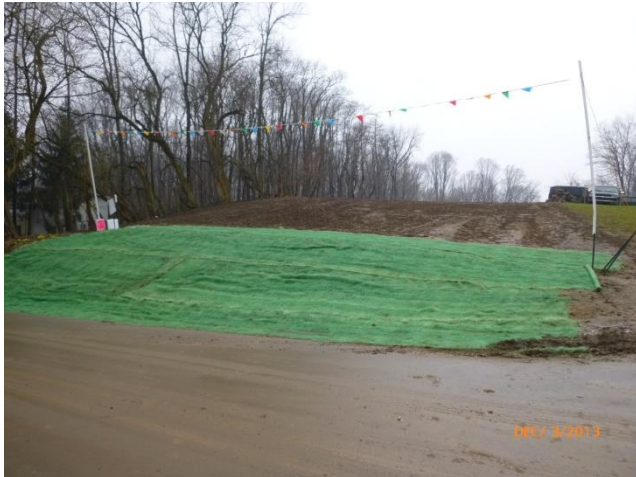
Goldring rd. Erosion control blanket installed, Sta.#1906+73.

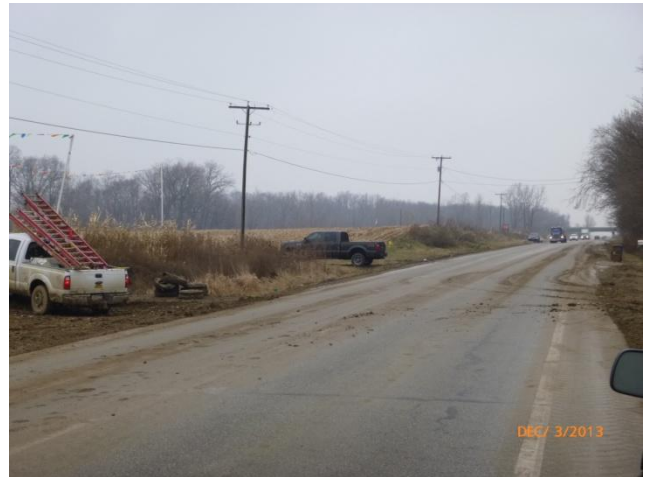
SR HWY 39 muddy rd. compliant investigation Sta.#2170+54.

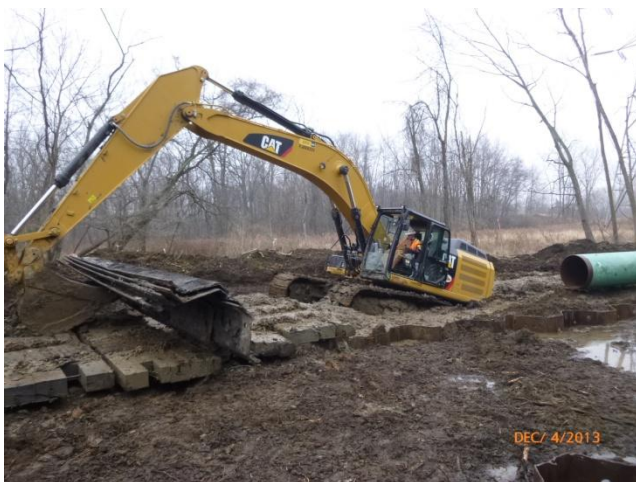
West of N.200E. muddy conditions at Sta.#1261+50.

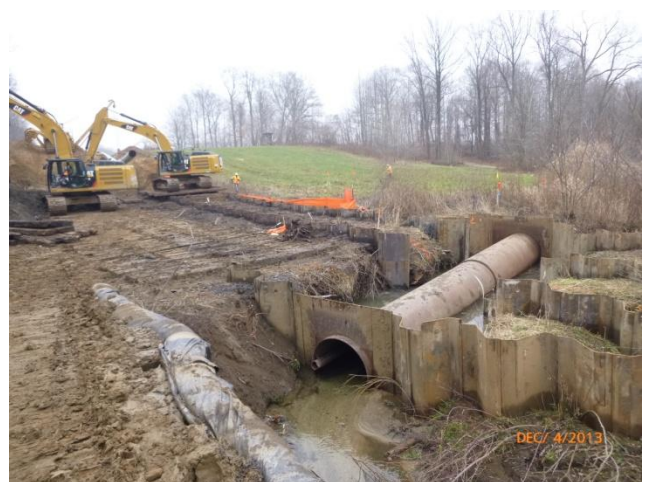
DNR s-496-c flume dry crossing prep. at Sta.#1662+31

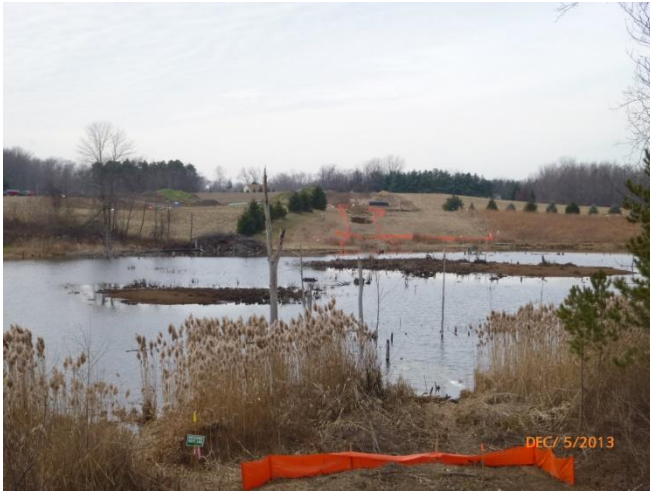
Anticline caused by HDD pressure in w-496-c, Sta.#1655+00

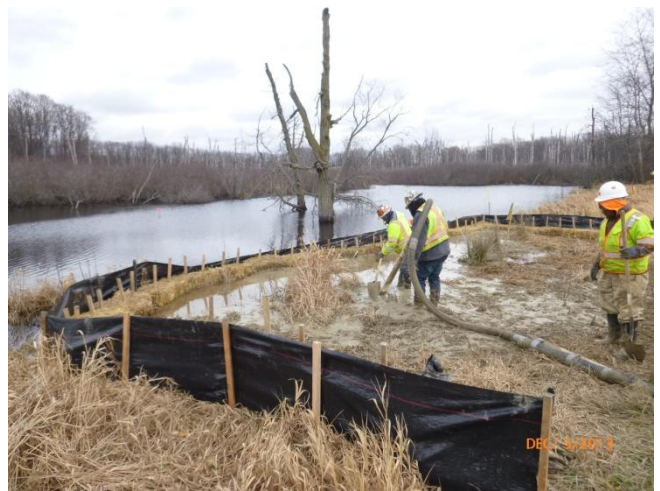
HDD mud at w-517-e clean up 100% contained, Sta.#2771+29

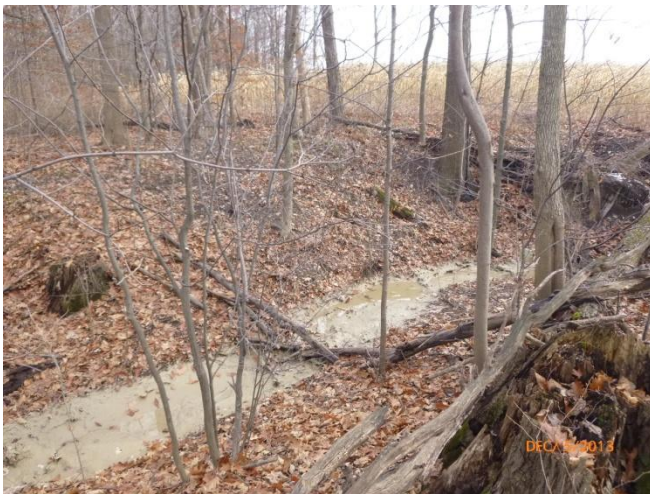
East of w-517-e drilling mud run off ROW, Sta.#2799+00

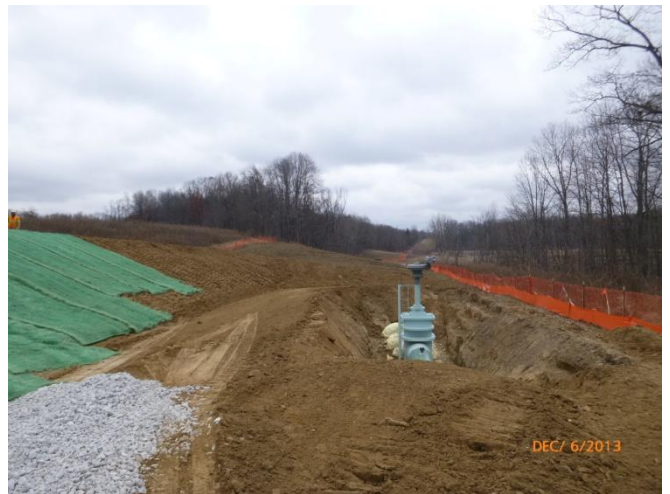
Erosion blanket + ECD's installed above w-497-c, Sta.#1714+55.

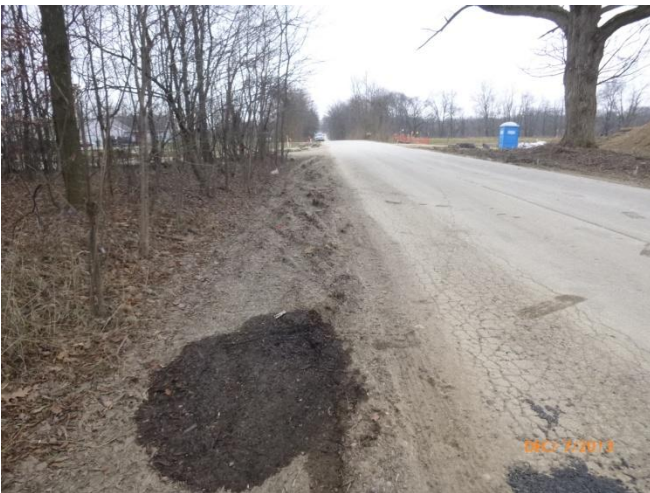
Small oil spill reported for clean up on N.850E. Sta.#2819+91

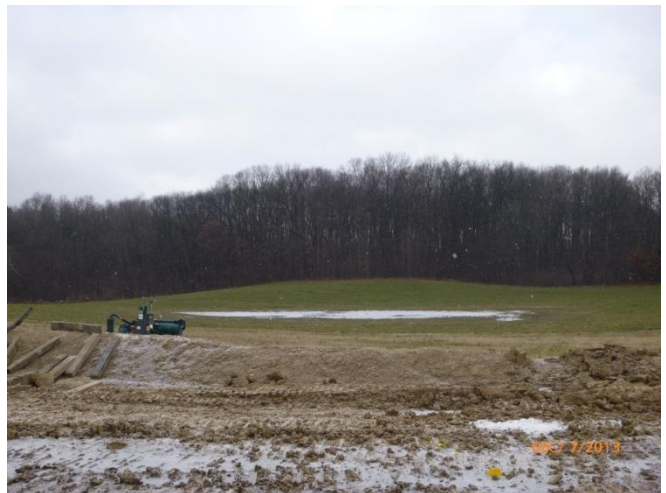
W-517-e HDD H2O discharge location approved, Sta.#2806+00.
